DEPT. OF NATURAL RESOURCES

REF: NE00628

NEBRASKA DEPARTMENT OF NATURAL RESOUCES DAM INSPECTION CHECKLIST

DAM NAME: SPENCER DAM	NID #: NE00628 PLAN #: P-3650G APP #: A-1725 DAM APPROVAL STATUS: Approved		
PRIMARY OWNER: Nebraska Public Power District - Spencer	LOCATION: QRT: NW SEC: 30 TWP: 33 RGE: 11 W COUNTY: Holt STREAM: NIOBRARA RIVER		
89566 492 Ave Spencer, NE 68777	HAZARD CLASS: Significant YEAR COMPLETED: 1927 HYDRAULIC CAPACITY: Adequate		
ADDITIONAL OWNERS: Nebraska Public Power District	DAM HEIGHT: 29 feet DRAINAGE AREA: 7084800 acres MAX.STORAGE: 16487 acre-ft DAM TYPE: RE - Earthfill NORMAL STORAGE: 5306 acre-ft DAM LENGTH: 3700 ft		
	INSPECTED BY: Stacey Kolar & Jeramy Sedlacek INSPECTED: 4/24/2018 REVIEWED BY: Mark Noble

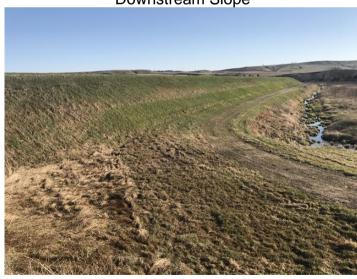
18. Erosion			
	19. Rodent Holes			
	20. Vegetation Condition Inadequate			
	Downstream Slope			
	21. Settlements, Slides, or Cracks			
	22. Erosion			
	23. Trees			
\checkmark	24. Rodent Holes	one found

25. Problems at Drain or Well Outlet	Toe drains running water, but appear to need routine cleaning.	Est.Flow Rate:	
\checkmark	26. Seepage or Boils	Wet area just d/s of dam, just N of north service road at toe of slope	Est.Flow Rate:	
	Principal Spillway Outlet	Size and Type: See comments for Principal Spillway Inlet	Est.Flow Rate: 2000 cfs	
$\sqrt{}$	27. Spalling, Cracking, or Scaling	See comments for Principal Spillway Inlet

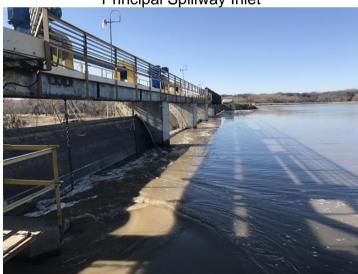
6. Erosion			
	7. Trees			
	8. Rodent Holes			
	Upstream Slope			
	9. Settlements, Slides, or Cracks			
	10. Erosion			
	11. Trees			
	12. Rodent Holes			
	Principal Spillway Inlet	Water Surface EL: 3 feet below top of tainter gates and stop logs Size and Type: Concrete spwy with 4 tainter gate bays & 5 bays of stop	Est Flow Rate: 2000 cfs logs Drawdown: no drawdow	
<u> </u>	13. Spalling, Cracking, or Scaling	Floor of concrete spwy is worn with exposed rebar. Dissipators worn dov

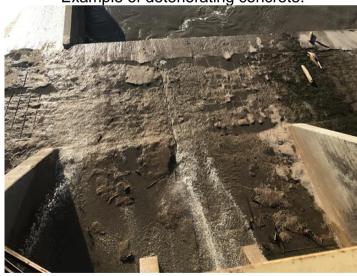
Example of deteriorating concrete.

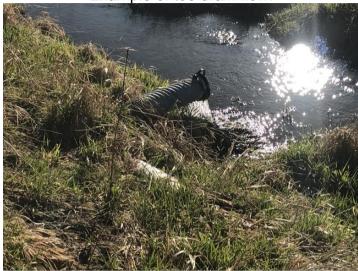
Example of toe drain flow.

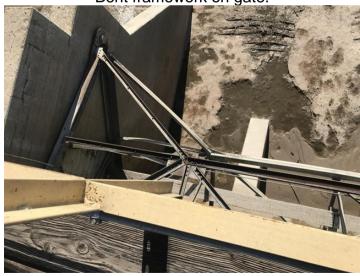
Condition Assessment:	Fair - Deficiencies exist which could lead to dam failure during rare, extreme storm events.
Additional Comments:	The angle iron frame on the 3rd gate in from the northernmost gate appears to be bent.

Bent framework on gate.
